# Downtown Amherst, Virginia

## Pedestrian Safety and Walkability Study

**December 2016**

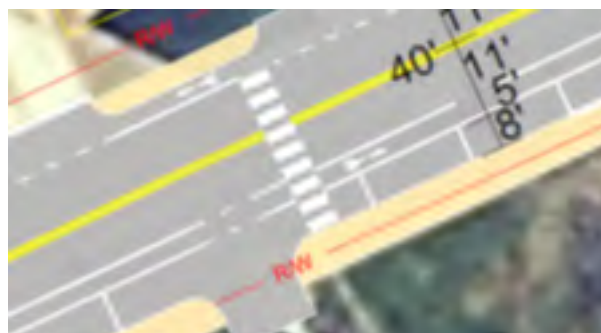
**Figure 6: Mid-Block Crossing Illustration**

*This image illustrates a proposed mid-block crossing with high emphasis pavement markings.*

Considering the travel speeds, gaps, and volume, it appears that mid-block crossings are acceptable. It is recommended, however, that in the future crosswalk signage be provided and the crossings marked using the high emphasis style pavement crosswalk markings, as illustrated in Figure 6 below.

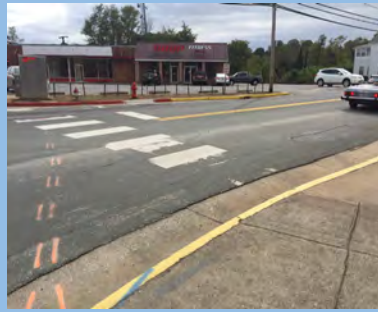
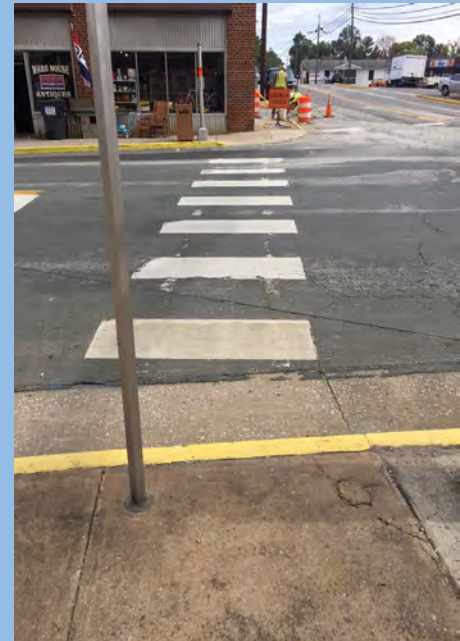
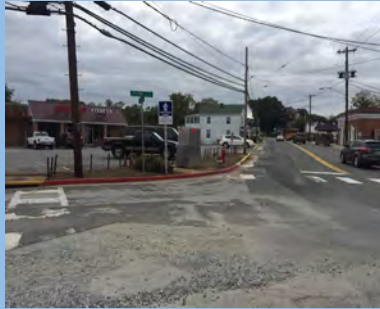
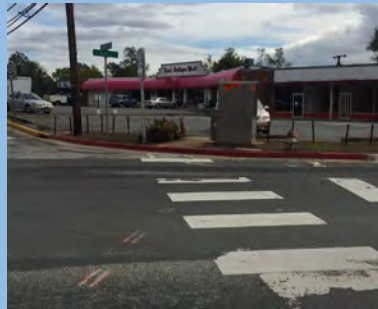
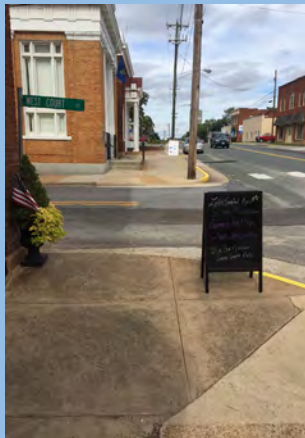
## Missing Sidewalk Ramps

These graphics were used during the public meeting to illustrate the location of sidewalk ramp and pedestrian signal improvements that are proposed in Phase 1. The missing pedestrian signals were subsequently added in November 2016.

During this walk it was noted that the intersection at Second St and Main St did not provide pedestrian signal heads or curb ramps for handicap accessibility to the crosswalk. This concern was communicated to VDOT and in November of 2016 the pedestrian signal equipment was improved to include the pedestrian signal heads. The addition of the missing curb ramps at this intersection and other locations along the study corridor will occur in coordination with the pending VDOT repaving effort in 2017.

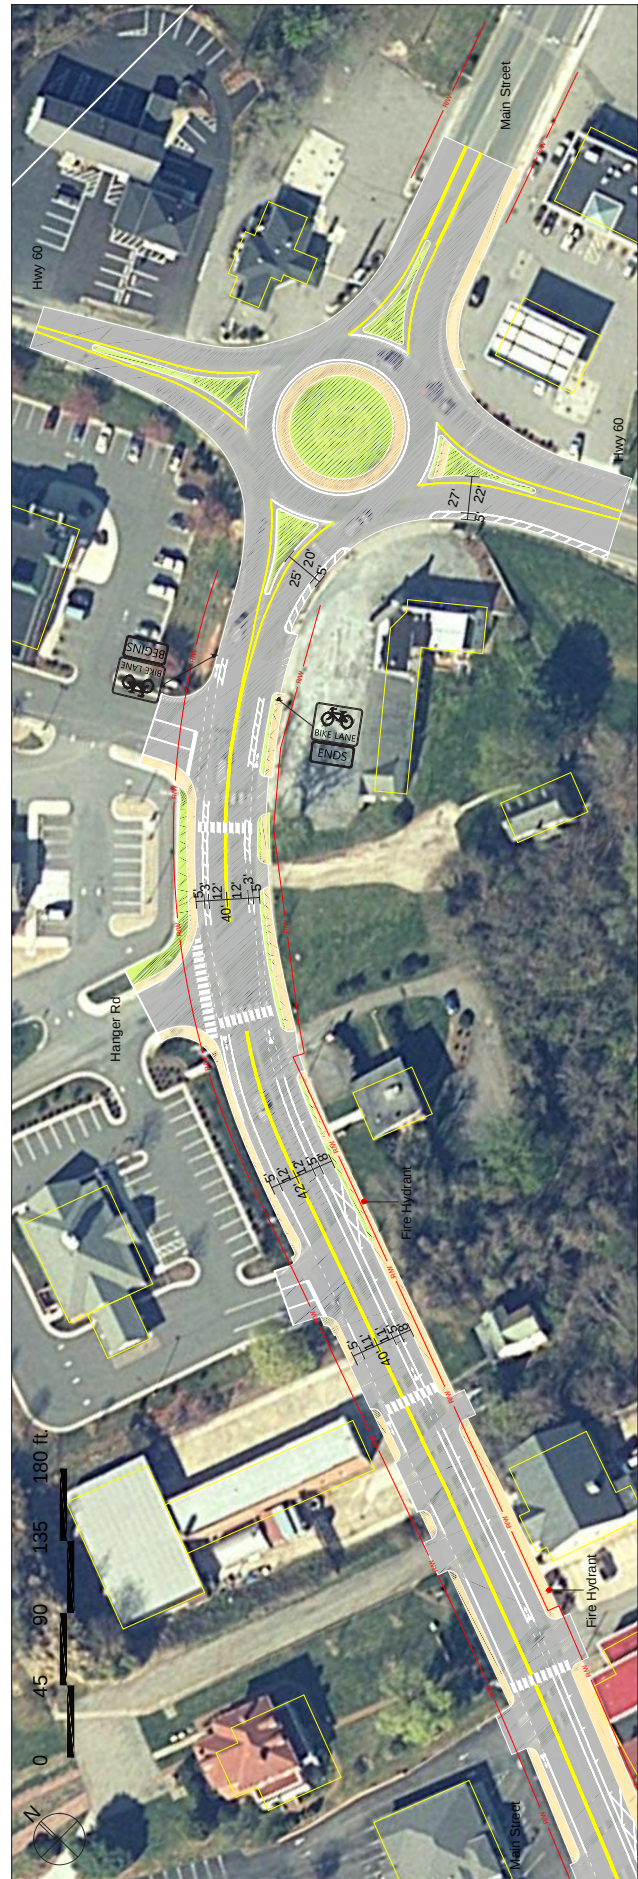
**Figure 9: Recommended Phase 2 Street Markings**

This graphic illustrates the pavement markings that are recommended for the study corridor following the upcoming repaving project. The southern half of the corridor is shown in the top image, while the northern half is shown below it. The existing right of way is marked by red lines, and the existing sidewalks are shown in beige.

Phases 1 and 2 will occur in coordination with the pending VDOT Main St (Route 29 Business) repaving effort. It is important to know that the study corridor constitutes only one portion of this repaving project. The full project will extend from the Route 29 Bypass overpass in the north to approximately Nicewood Pl in the south. As a further improvement to the ability to bicycle along Business Route 29, VDOT is creating pavement marking plans for bicycle lanes to both the north and south of the project study limits. These improvement will create contiguous bicycle lanes from Grandview Dr to the traffic circle along North Main St, and from just south of Second St to the library along South Main St. South of the library, the posted speed limit increases to 45mph. Due to safety considerations, bicycle lanes are typically not provided on roads with these vehicular speeds. As a result, bicycle lanes will not be provided south of the library, though "share the road" signs will be erected.

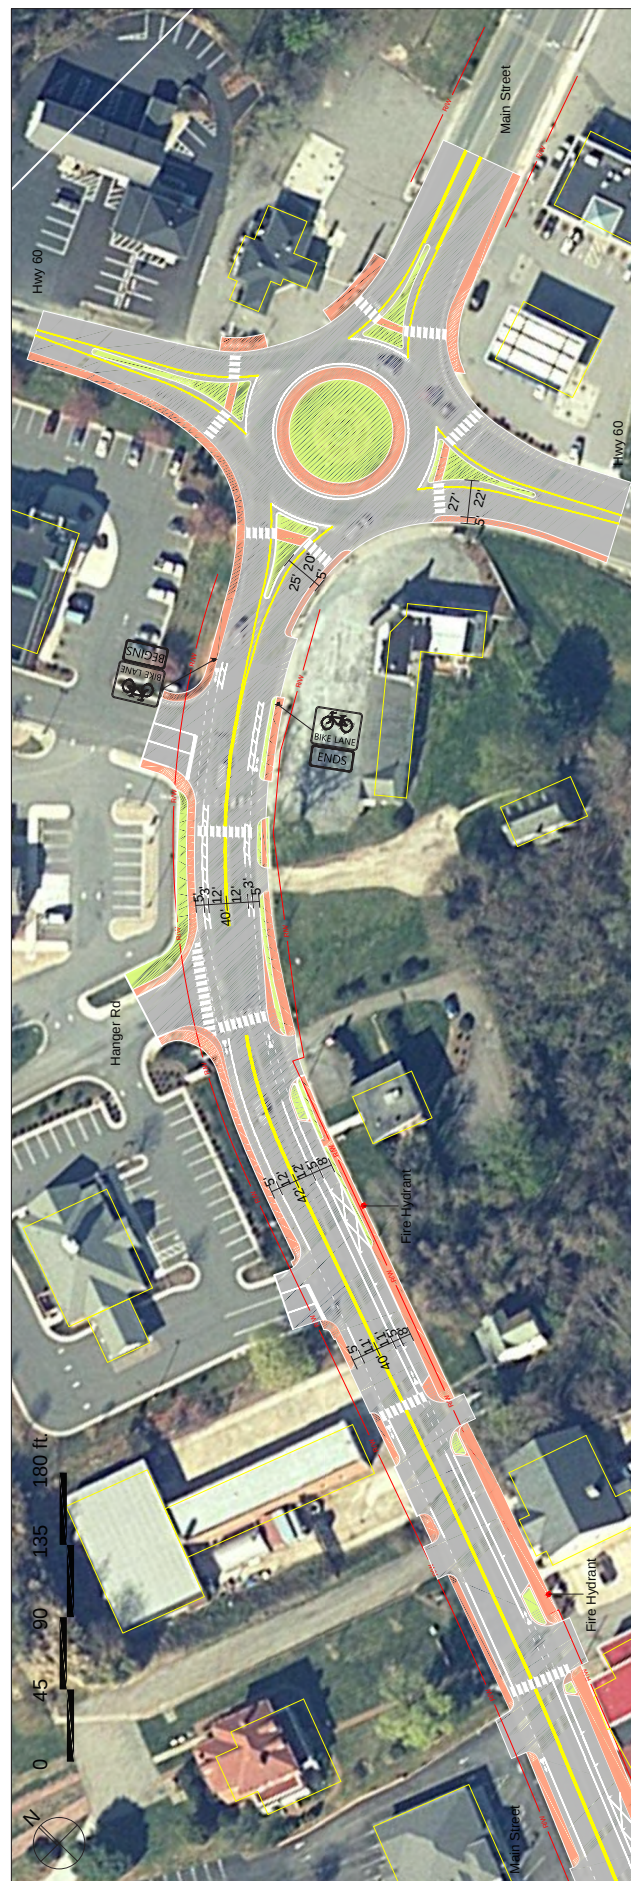
**Figure 10: Recommended Phase 3 Sidewalk Improvements**

This graphic illustrates the sidewalk improvements that are recommended for the study corridor in Phase 3. The southern half of the corridor is shown in the top image, while the northern half is shown below it. New sidewalks and curb extensions are shown in red, but final sidewalk material selections may change in the design process.

The Phase 3 improvements are illustrated in Figure 10 on the following page. These images can also be viewed at a larger scale in Appendix 2. There are several options and strategies that the Town may pursue to obtain funding for this work, which is initially estimated on a planning level to be in the order of \$1,475,000. This cost does not include the undergrounding of utilities, or other unforeseen utility work that may be conducted in coordination with the streetscape project.

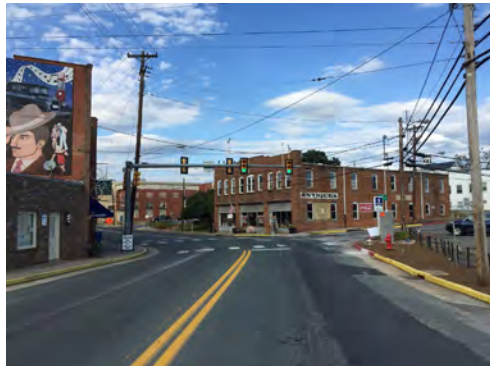
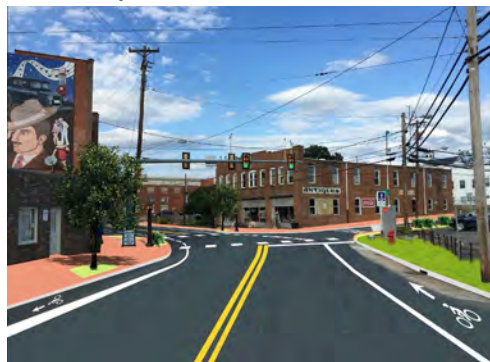
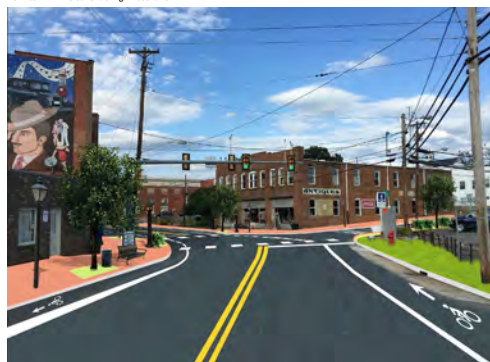
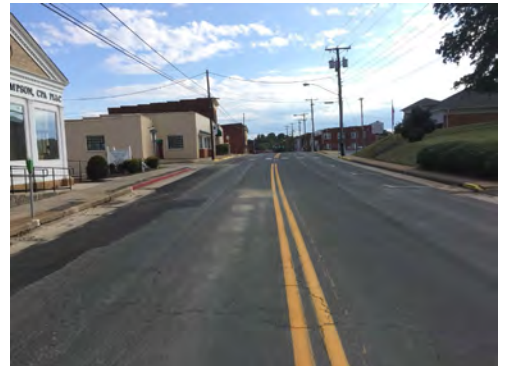
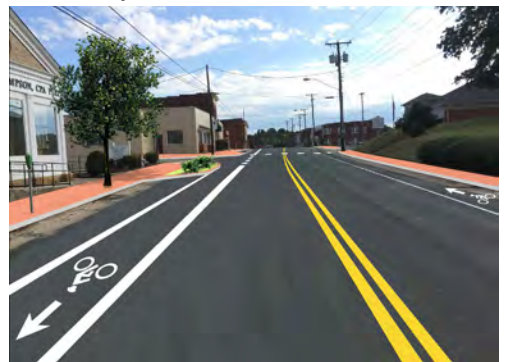
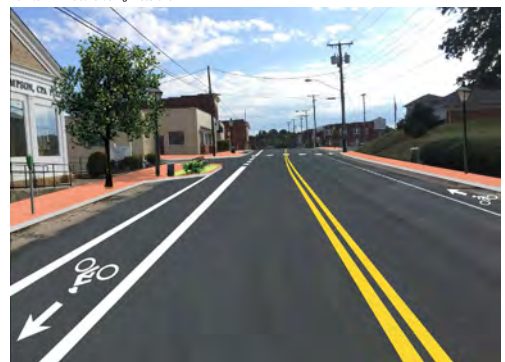
## Figure 11: Phase 3B Summary Graphics

These graphics were used during the public meeting to illustrate the appearance of Main St with streetscape elements such as benches, landscaping, and pedestrian-scale lighting that are recommended in Phase 3B. The top renderings were created during this study, while those in the blue box at the bottom were created for the Town Development Area study that was completed earlier in the year.

Phase 3B includes the addition of streetscape features to the improvements discussed in Phase 3A. In the study effort's community meeting, various options for hardware styles were presented. Examples ranged from architectural, utilitarian, minimalistic, modern, contemporary, and historical. Representative examples of options are included in Appendix 10 of this document. Typically in historical towns in Virginia, the historical themed streetscape elements are used. It was noted, however, that there could be mix of styles-- such as using a more modern style for bicycle racks-- if this expressed as a preference by the community through the final design process. Final selection of specific streetscape hardware specifications (type and color) will be addressed during the final design phase. A discussion of implementation strategies is presented in the implementation section of the document.

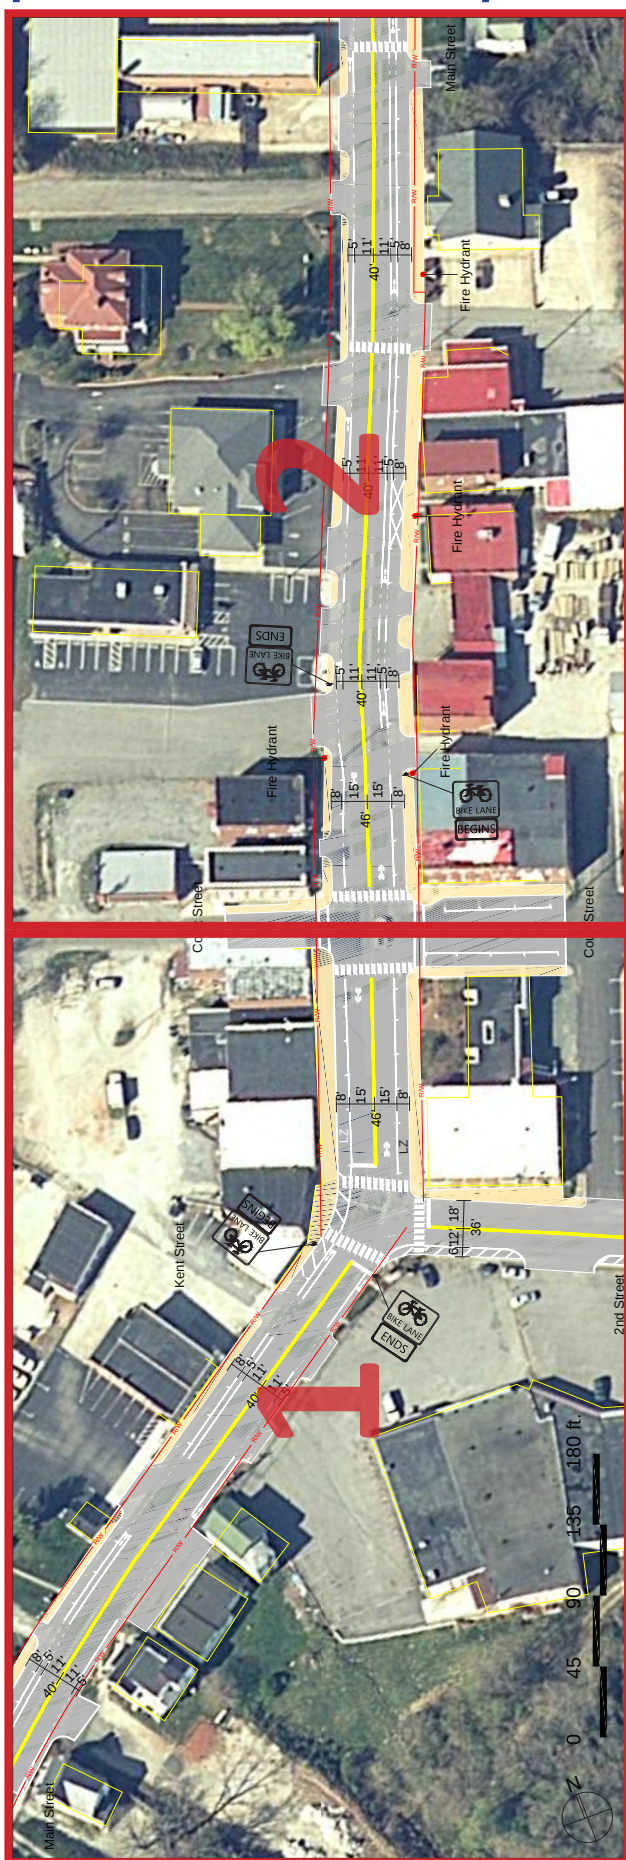
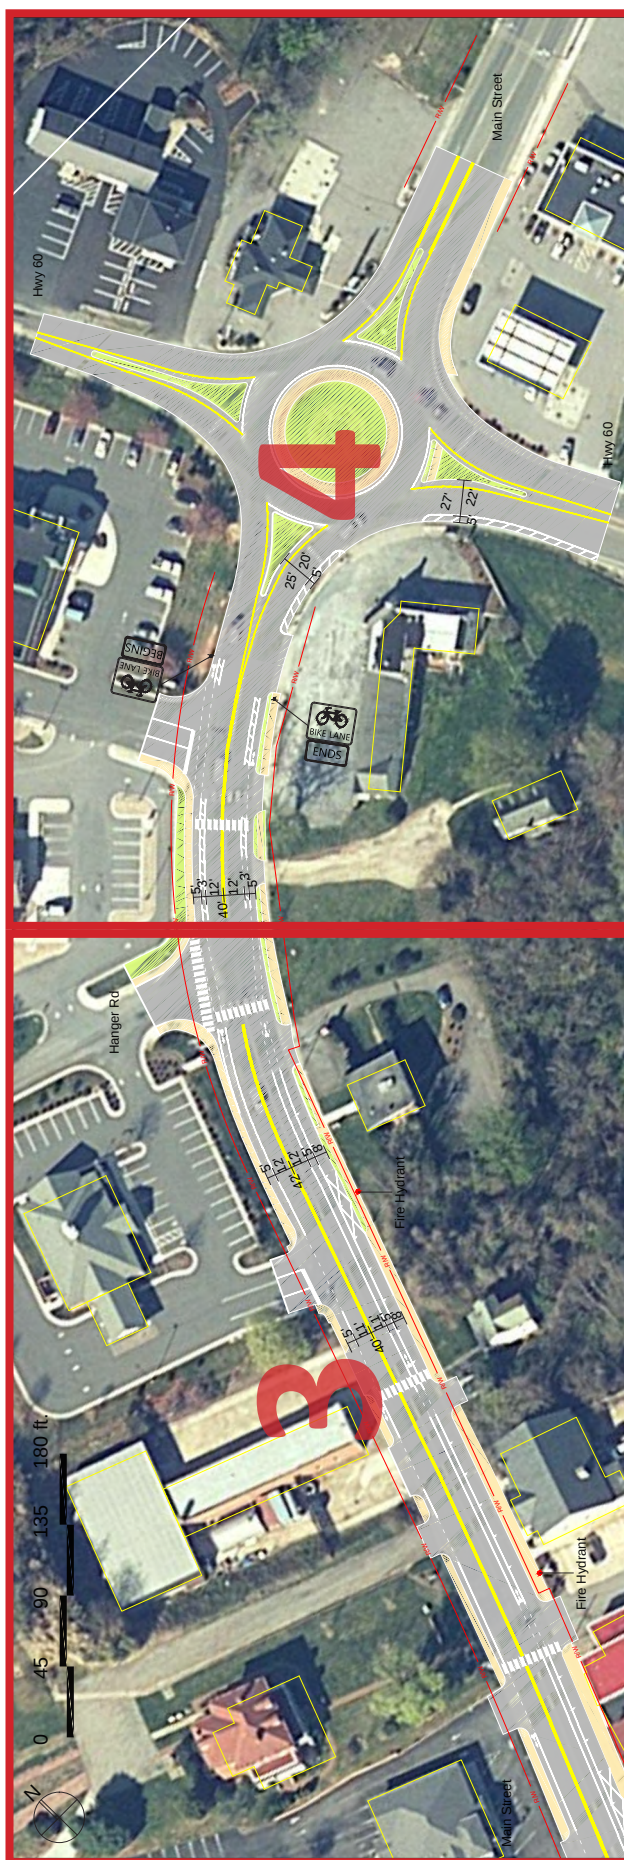
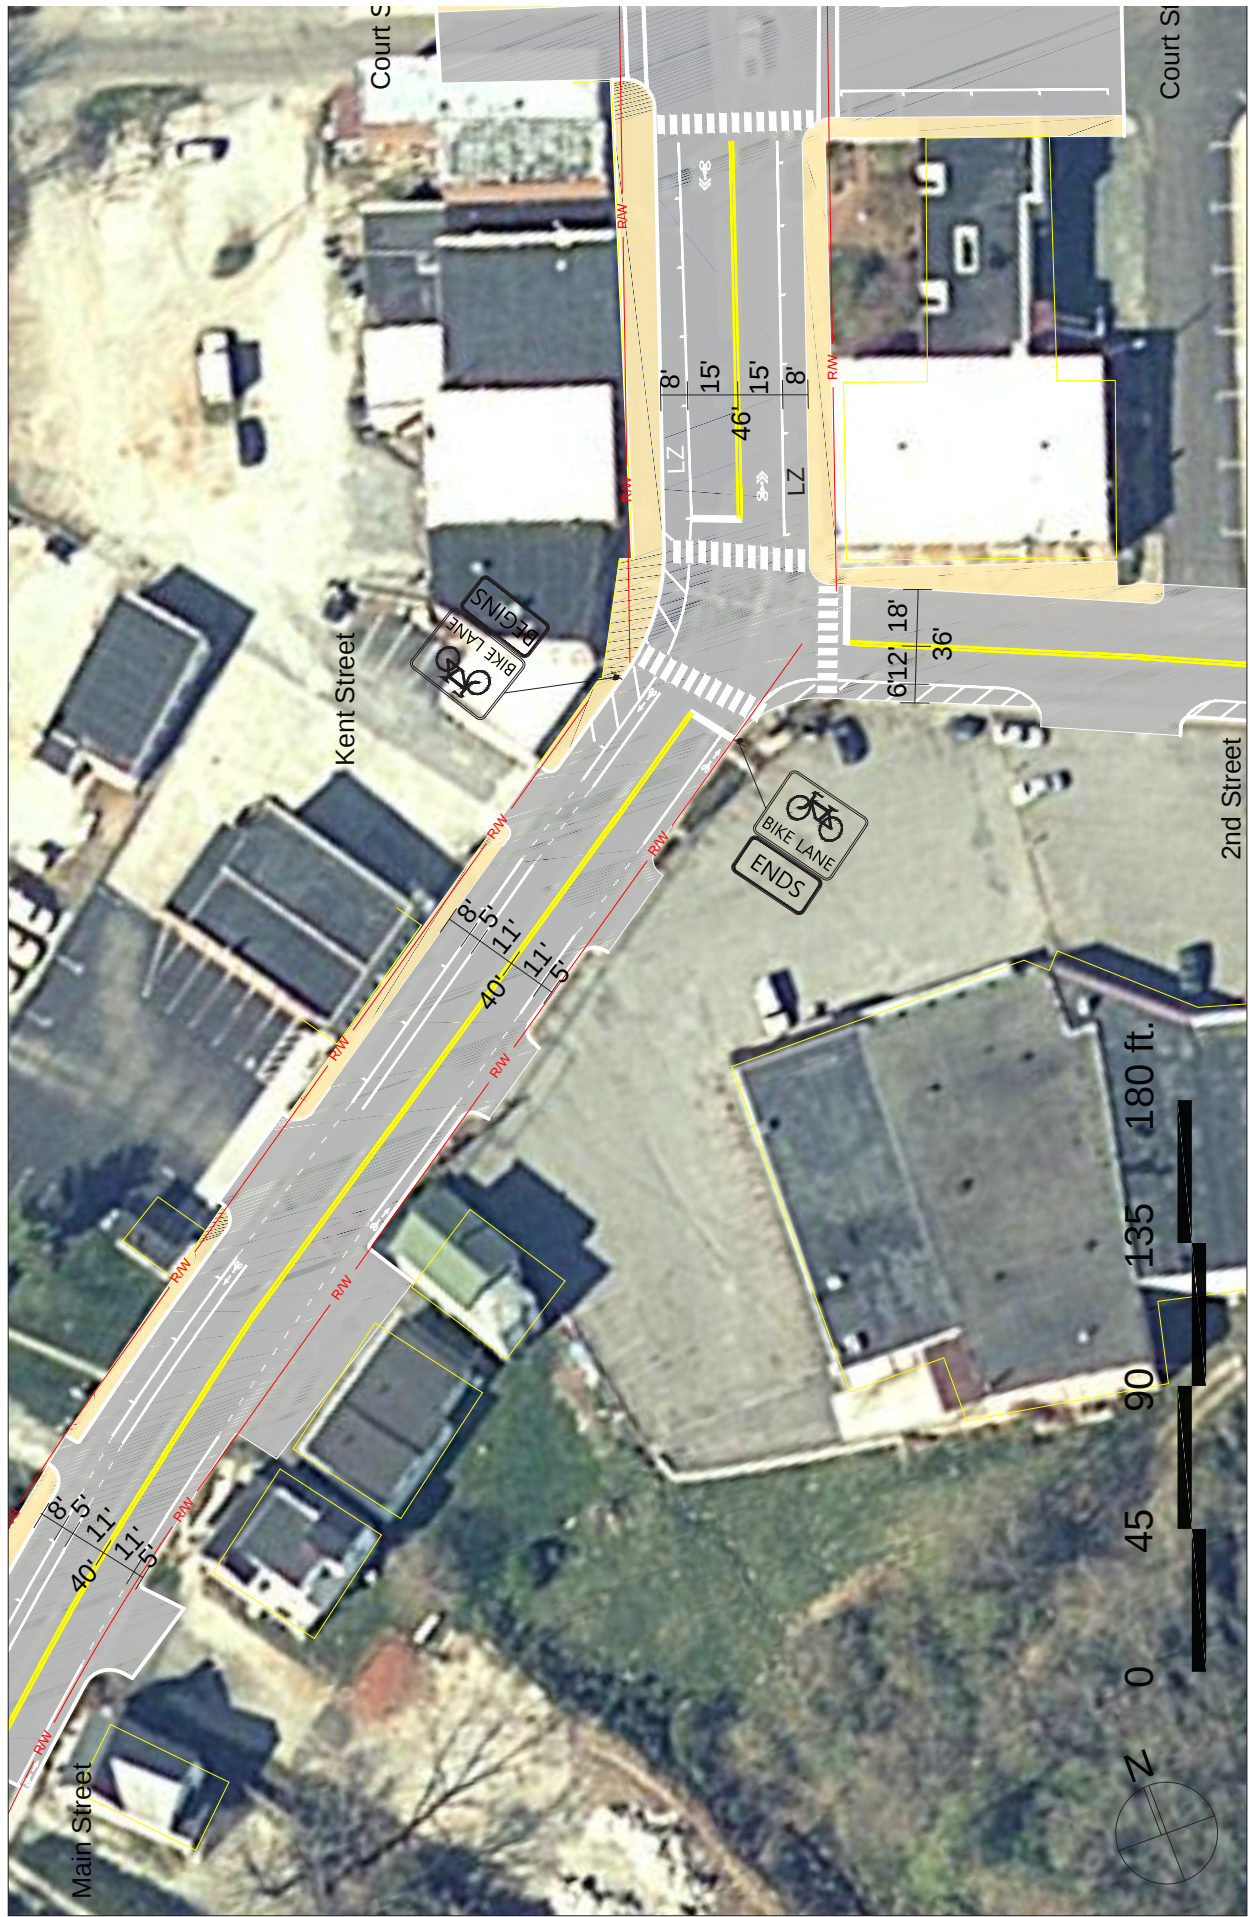
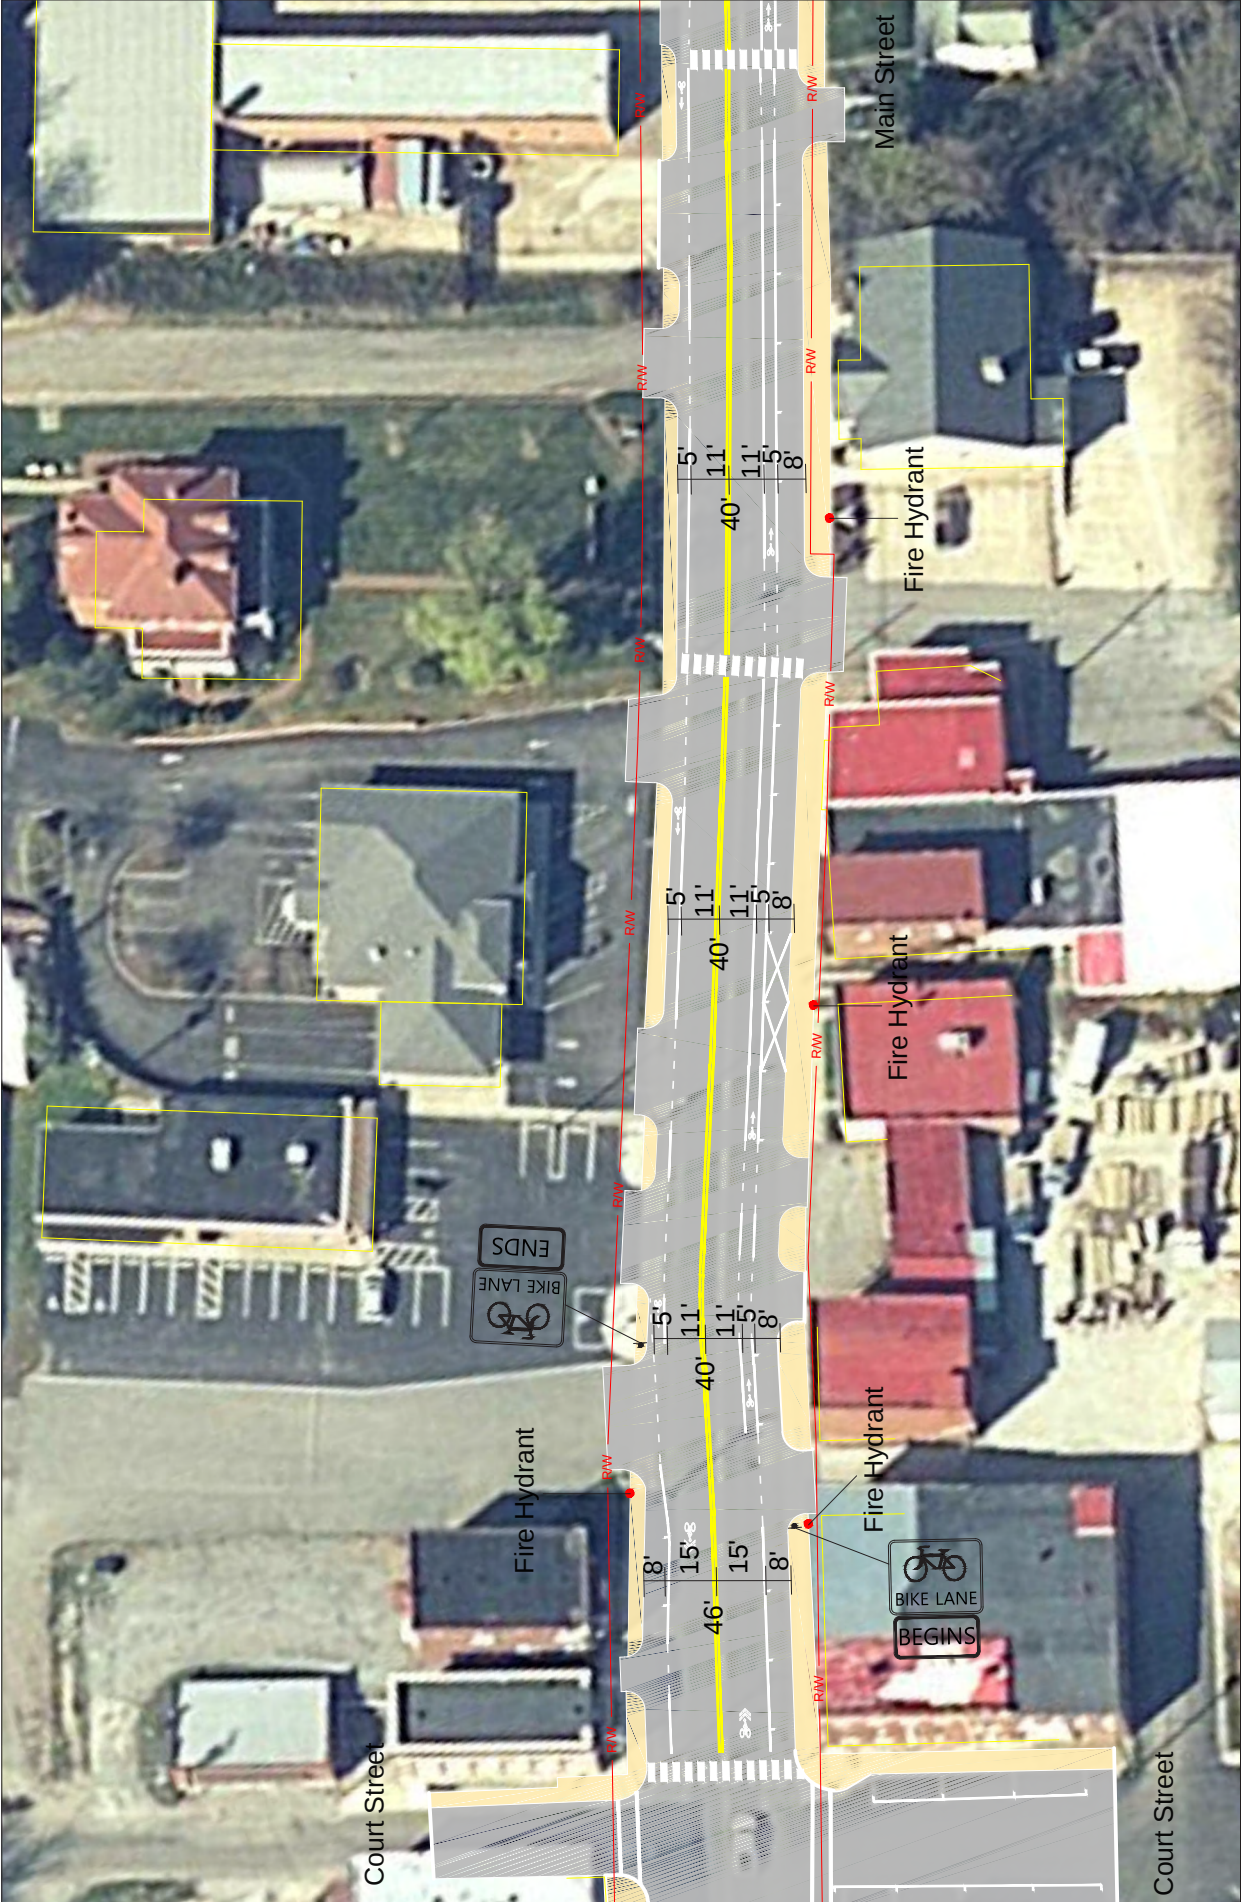
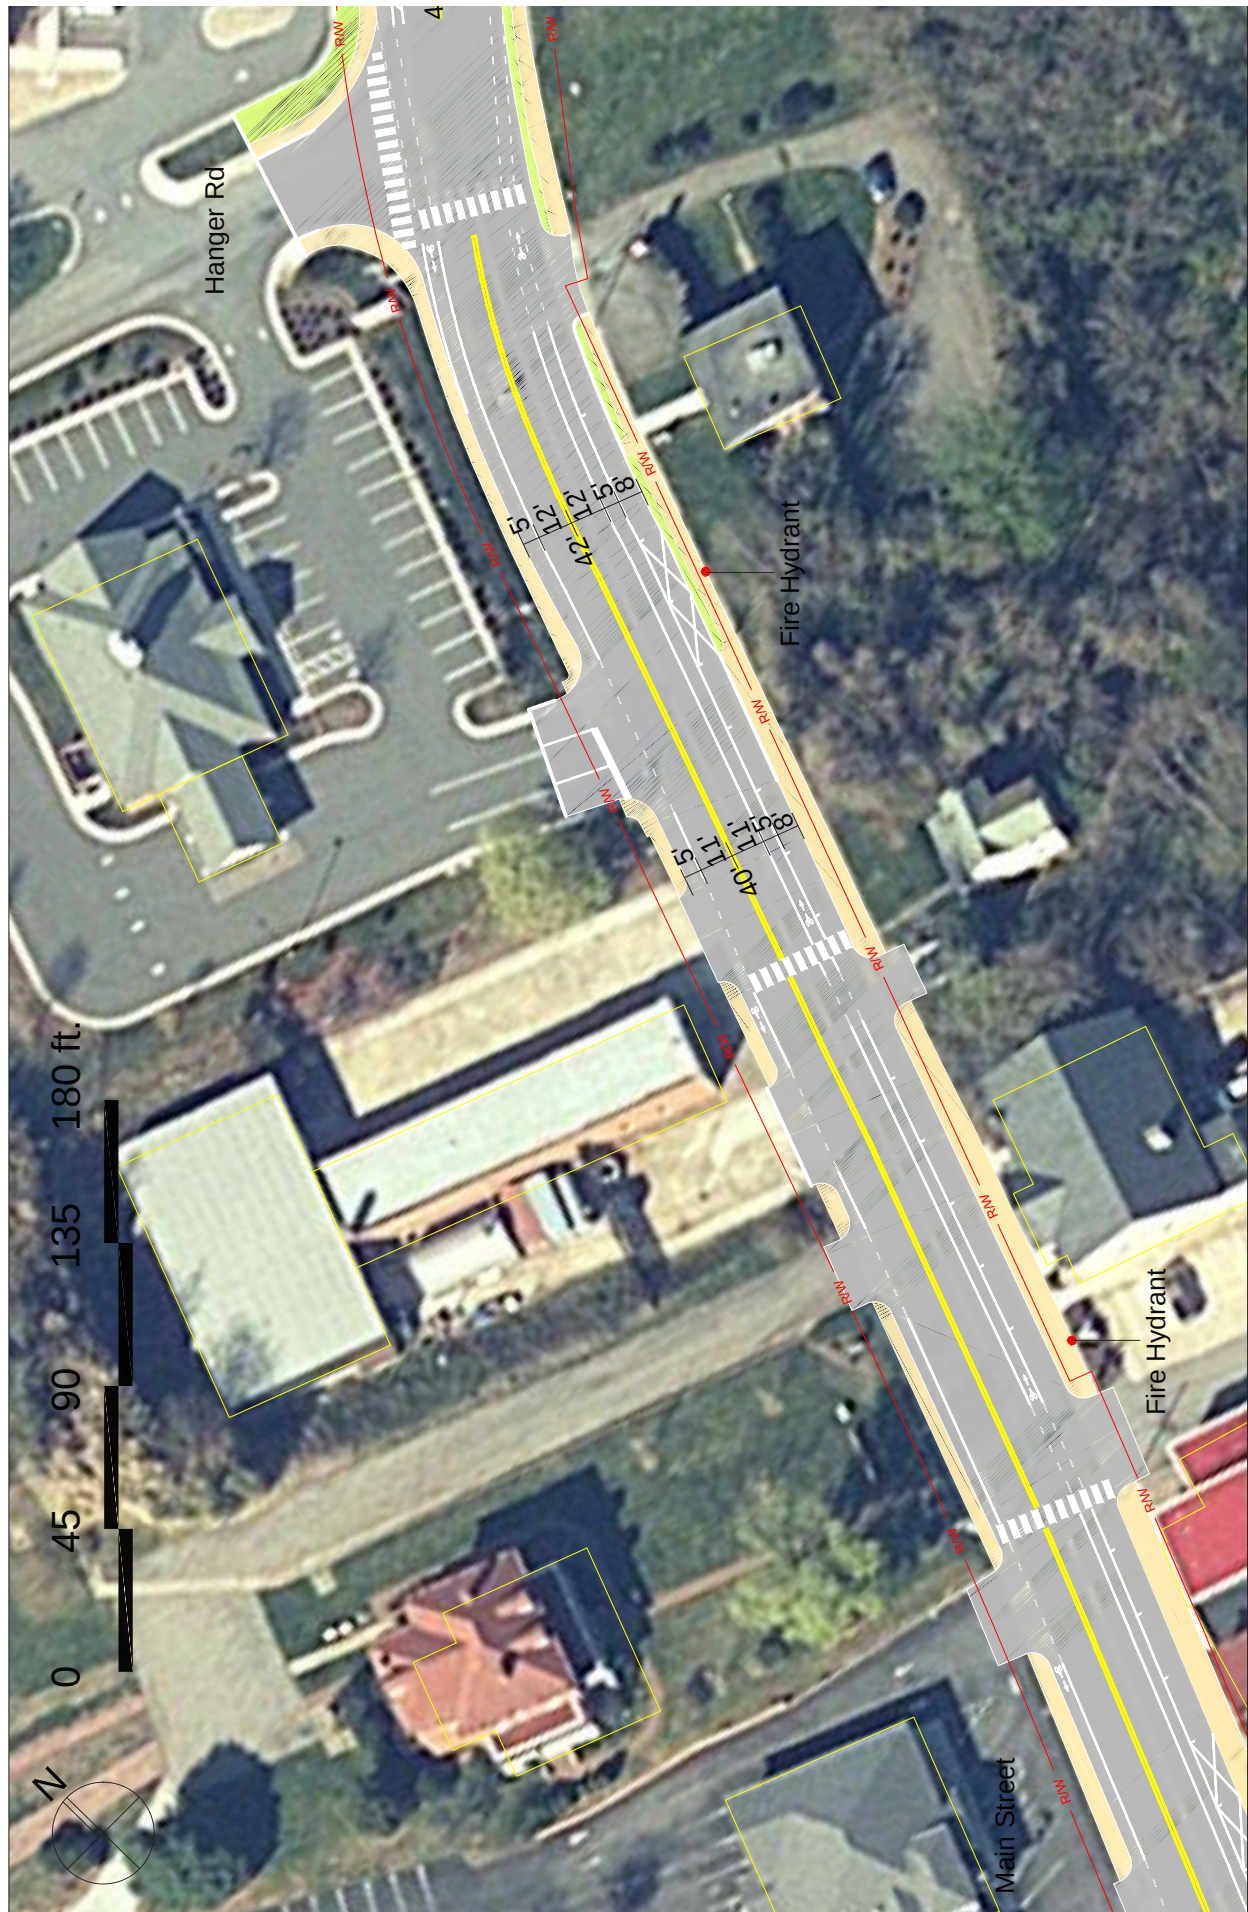
## Appendix 1: Phase 2 Improvement Plan

This graphic illustrates the pavement markings that are recommended for the study corridor in Phase 2. The four following pages display this image at a larger scale by dividing it into separate pages corresponding to the numbered red boxes.

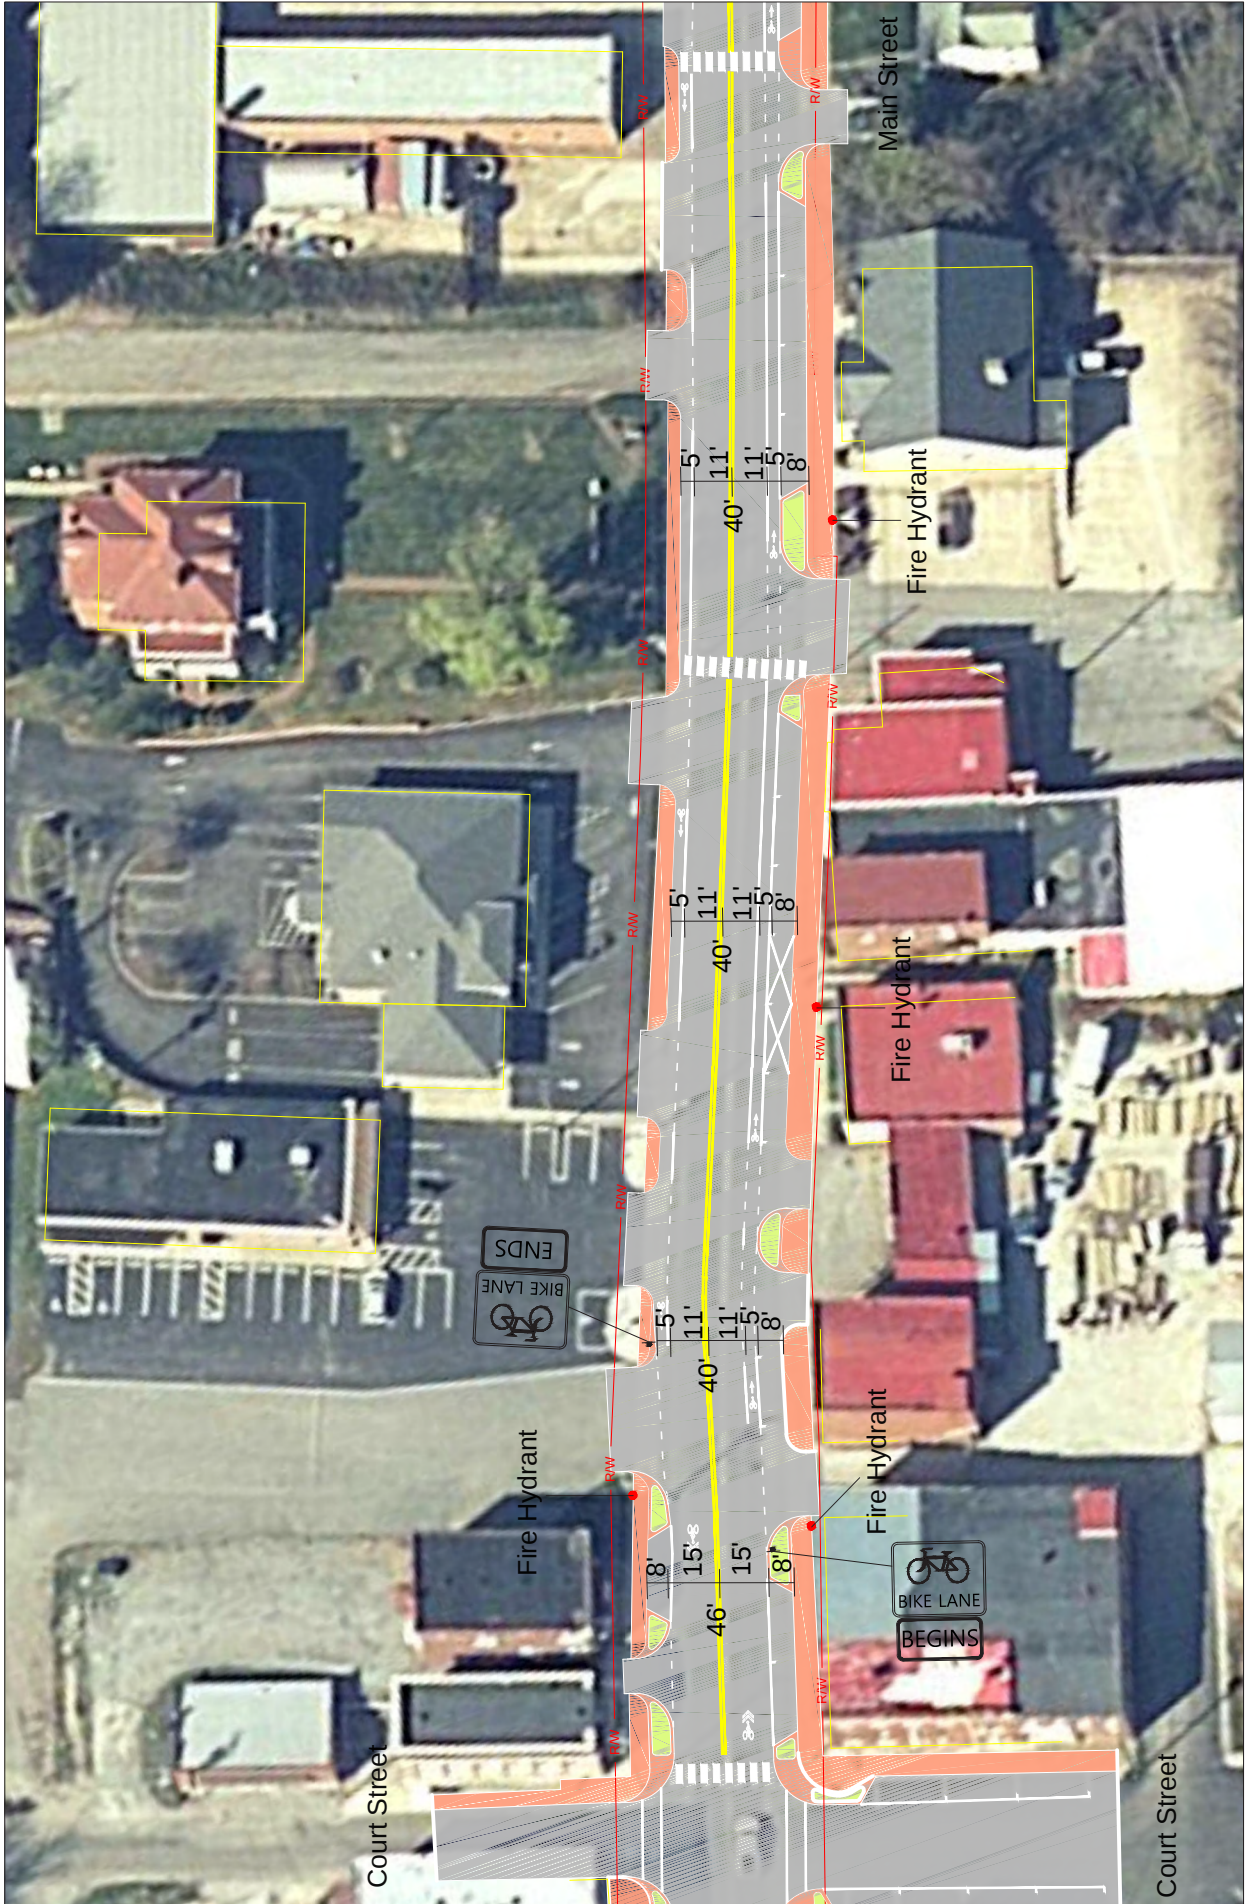
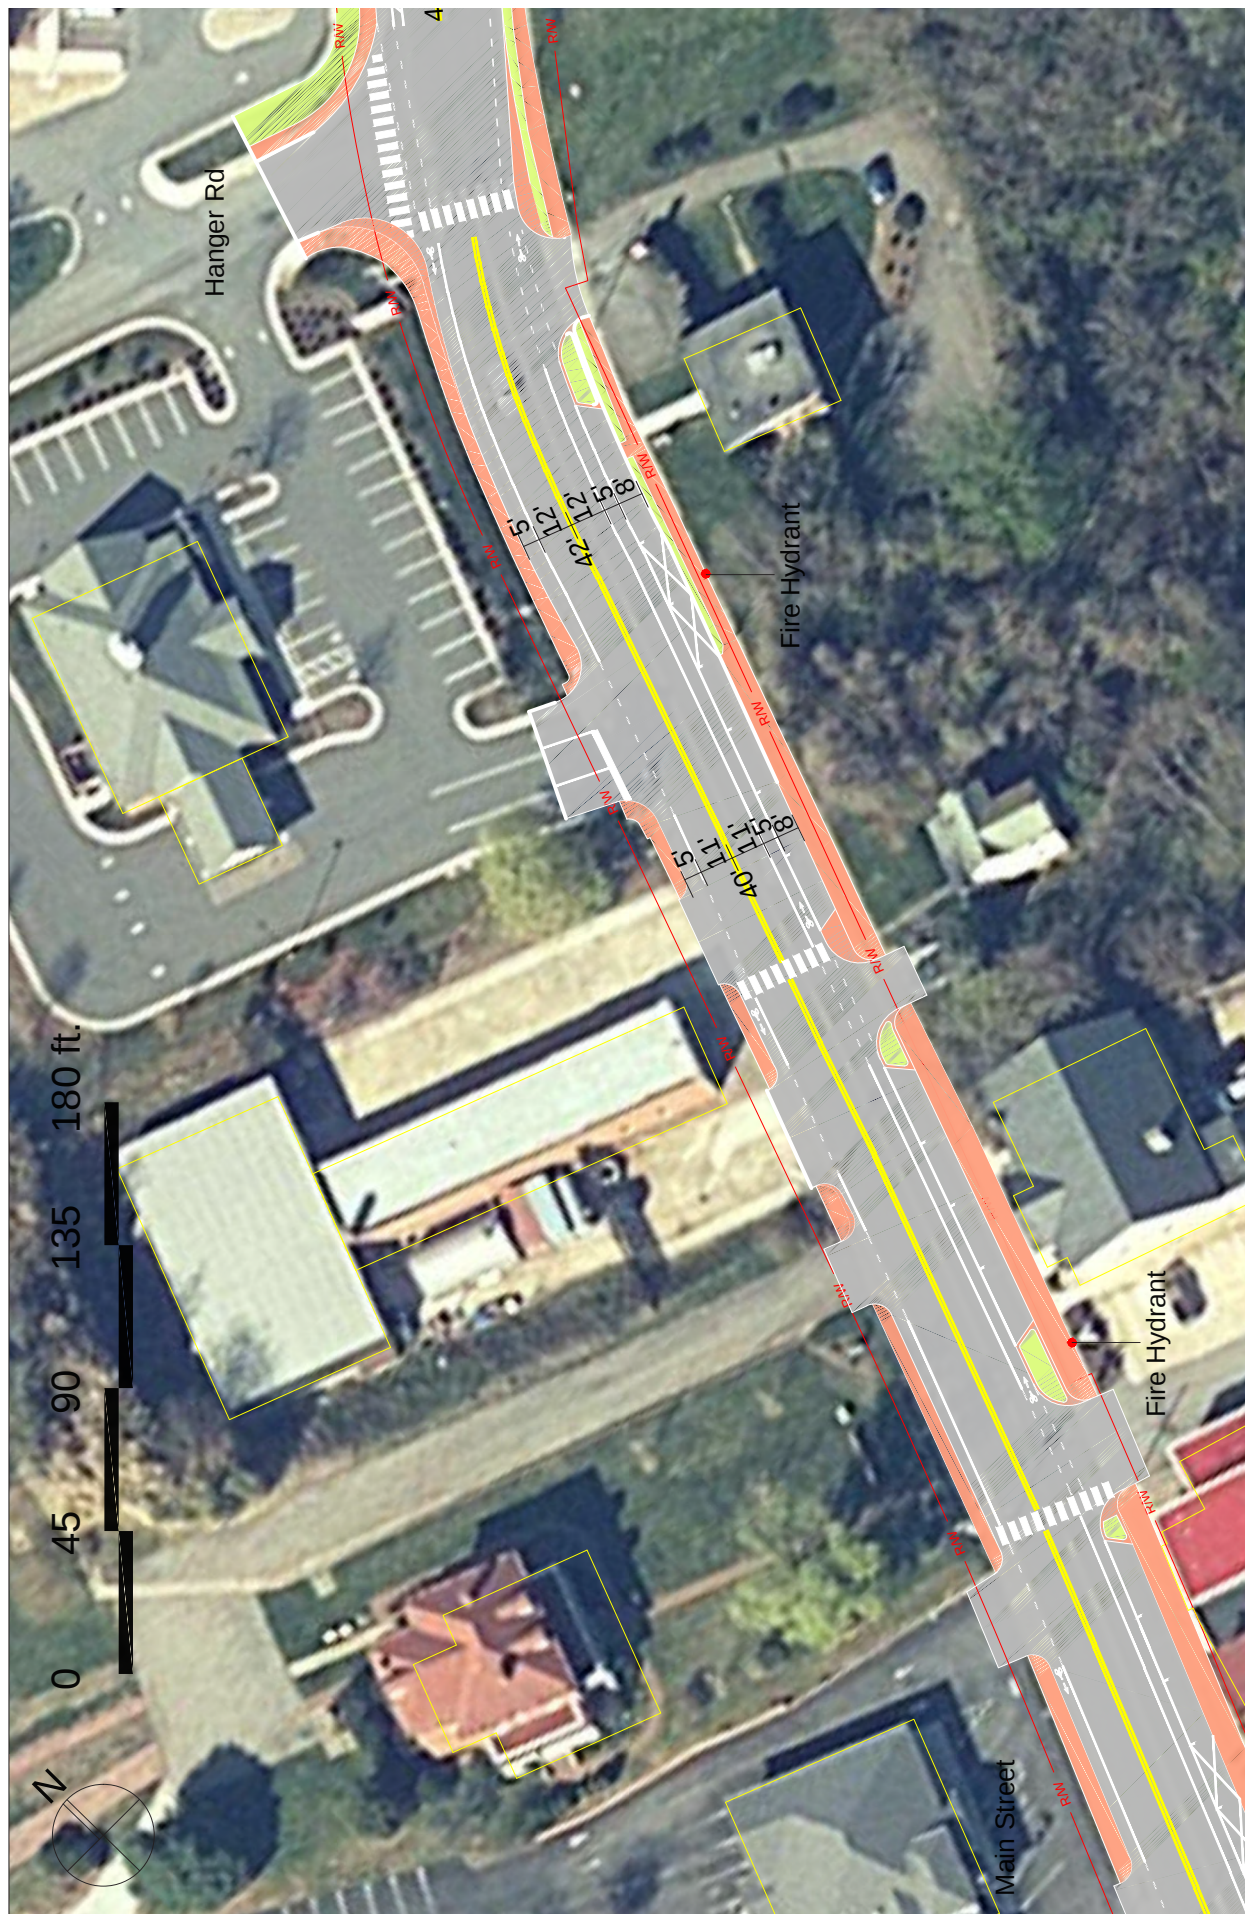
# Appendix 2: Phase 3 Improvement Plan

This graphic illustrates the pavement markings that are recommended for the study corridor in Phase 3. The four following pages display this image at a larger scale by dividing it into separate pages corresponding to the numbered red boxes.

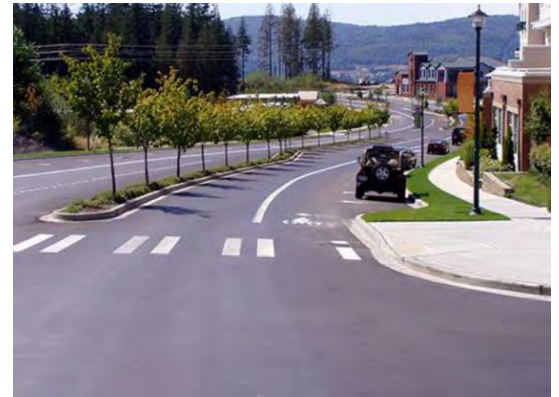
Bar Pairs crosswalks have several advantages over Longitudinal Lines crosswalks:

- [An FHWA study](#) of the Bar Pairs pattern concluded that it behaves comparably with the Longitudinal Lines pattern in terms of driver recognition and behavior,
- Similar cost as Longitudinal Lines crosswalks (although installation is slightly more complicated, the Bar Pairs crosswalk uses less marking material),
- Easier for motorcyclist/bicyclist traffic to avoid traveling over the pavement marking material, which may be slick when wet, and
- Easier for pedestrians to avoid stepping directly on the pavement marking material, which may be slick.

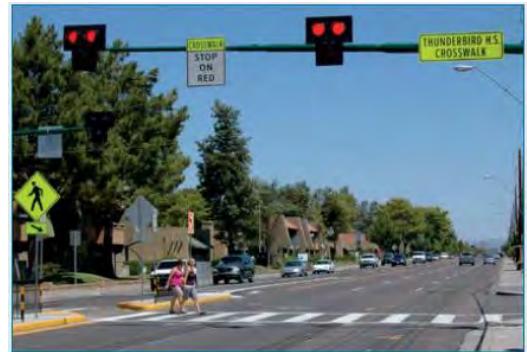
Pedestrian Hybrid Beacons (PHBs) may be used to control a midblock pedestrian crossing if warranted, designed, and operated as per Chapter 4F of the 2009 MUTCD. As per [Official Interpretation 4\(09\)-14\(I\)](#), a red clearance interval is permissible and should be considered between the start of the steady red phase and the start of the pedestrian walk interval, and then again between the end of the pedestrian walk interval and the end of the alternating flashing red interval. The duration of the flashing yellow interval should be as per [Official Interpretation 4\(09\)-32\(I\)](#).

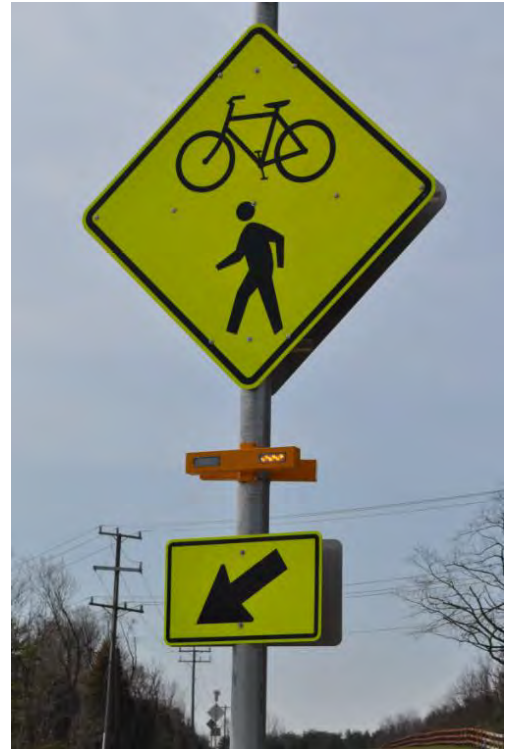
The sign and light components of the RRFBs should be prominently visible to approaching vehicles, and the RRFBs should have side indication lights informing pedestrians when the flashers are activated.
